# Pod-Driven Classic

The repower of a wood motoryacht with pod-drive propulsion required rebuilding the entire bottom, but the resulting appearance and performance are exquisite.

by Eric Sorensen

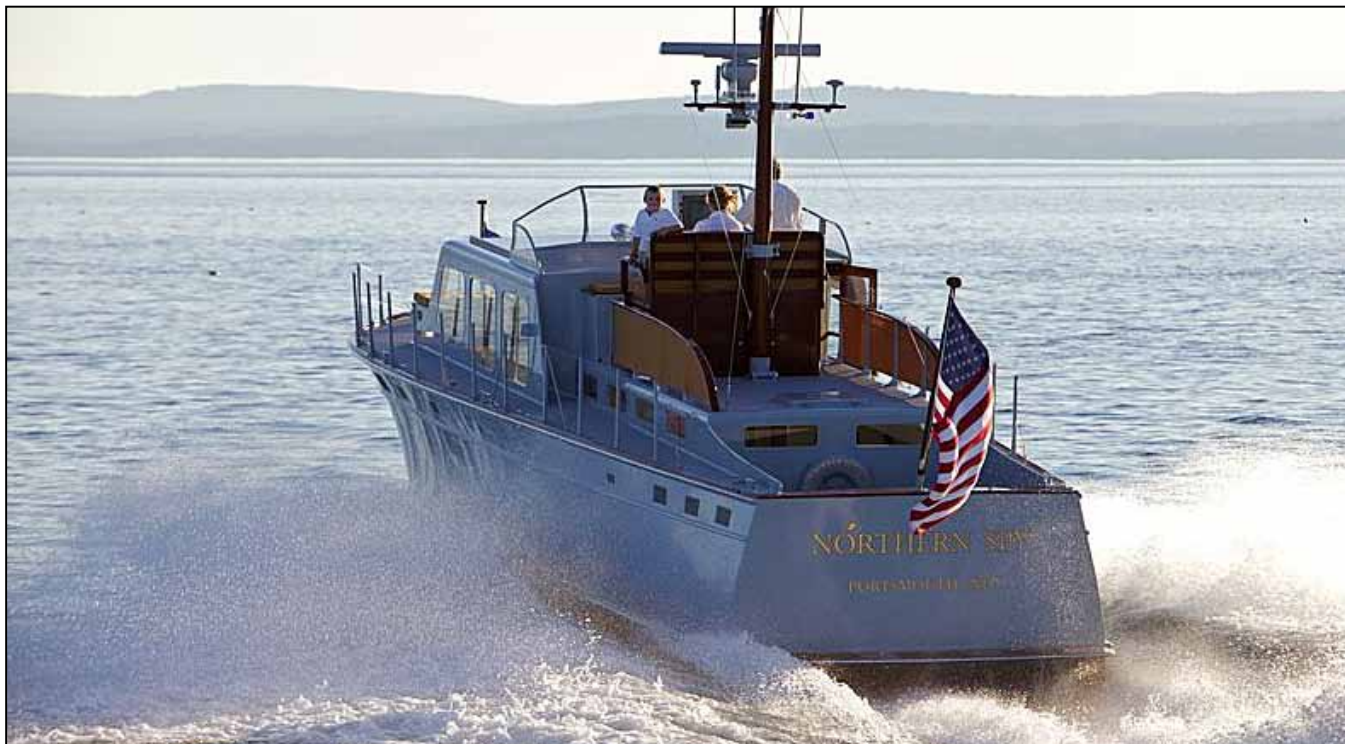
**Above**—When Northern Spy, a 45' (13.7m) 1954-vintage Huckins motoryacht was rebuilt at Yachting Solutions in Rockport, Maine, last year, she was repowered with Volvo Penta's Inboard Propulsion System (IPS) pod drives. The result is a nimble classic with improved handling and fuel economy.

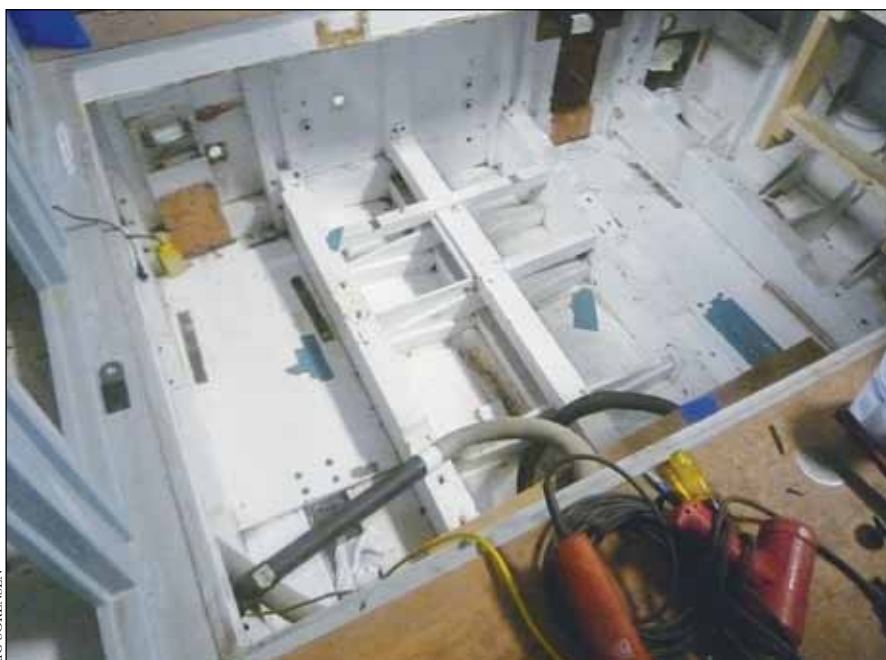
The engineroom early in the rebuild, just after the conventional V-drive Cummins diesels and running gear were removed. Engine beds, hull bottom, and most of the structural members pictured here were replaced in order to accommodate the new engines.

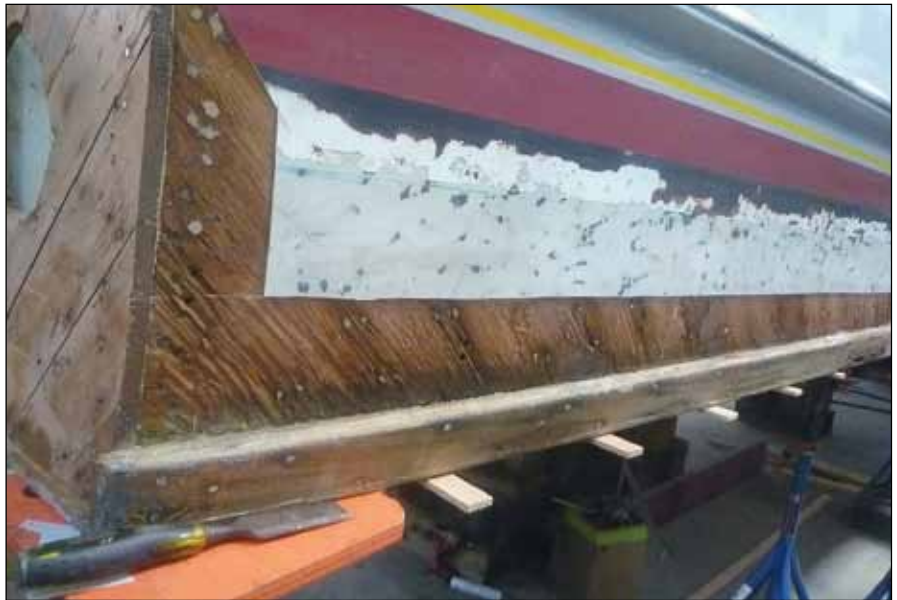
**Top**—The original mahogany double-diagonal planking had been resorcinol-glued and clenched-nailed. When the builders peeled away old fiberglass sheathing, they found deterioration, caused in part by electrolysis. All the planking in the engineroom sections was replaced up to about 1' (305mm) above the waterline.

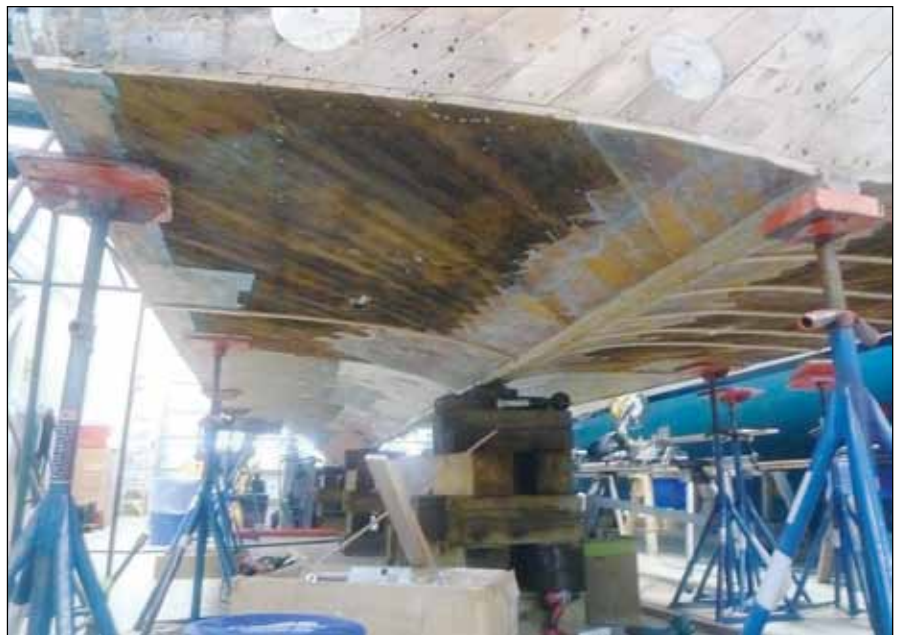
**Middle**—Although some rot was evident, the initial decision to replace the aft 9' (2.7m) of the bottom was made chiefly because the epoxy fiberglass laminate required by Volvo would not adhere to the oil-soaked planking below the engineroom.

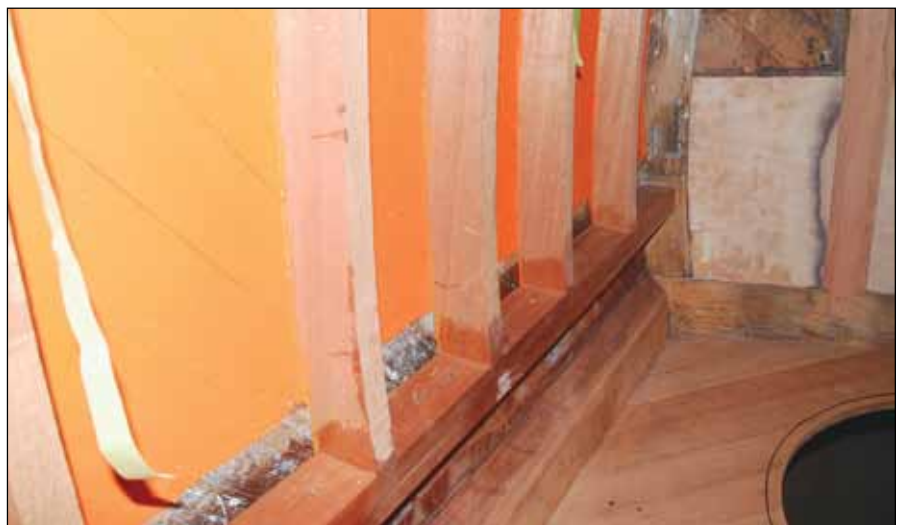
**Bottom**—To tie the new reinforced bottom into the hull sides, the internal fiberglass laminate—not yet applied here—continued up the hull sides as far as the a new longitudinal stringer. The new ribs were locked into the tops of the stringer, and spanned to the sheer clamp above.

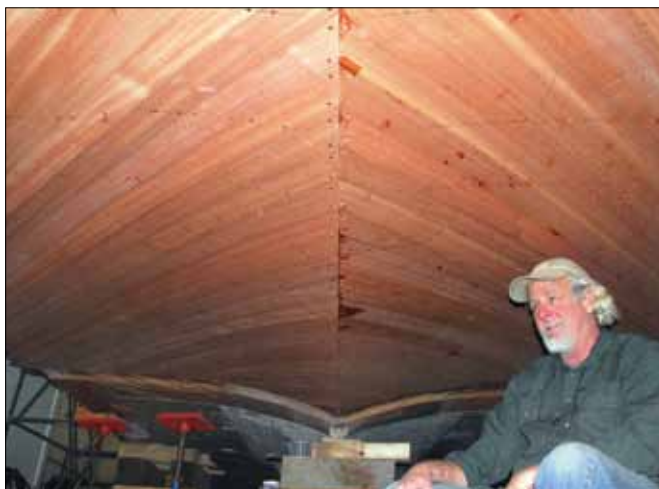
**Left**—With the new engine room planking complete, the transition to original planking is clearly visible just forward. The original plan was to make repairs only as needed to the forward sections, but that changed after crew dug into the structure.

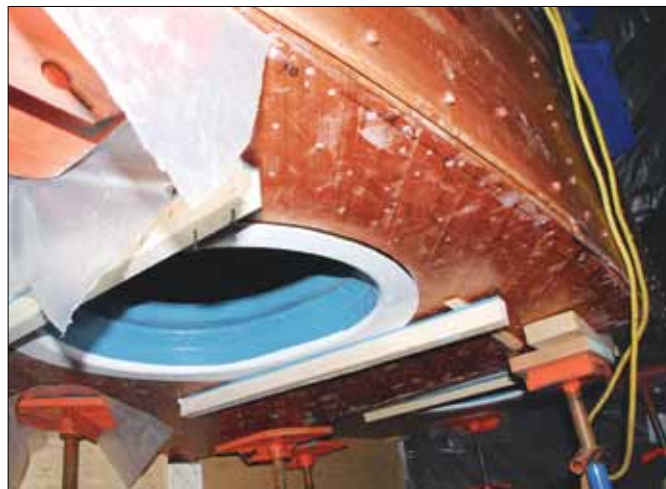
**Right**—The IPS hull rings are shimmed to fit the slightly concave bottom and create a fair surface along the buttocks. Inside, crews applied the thick laminate schedule that Volvo specified.

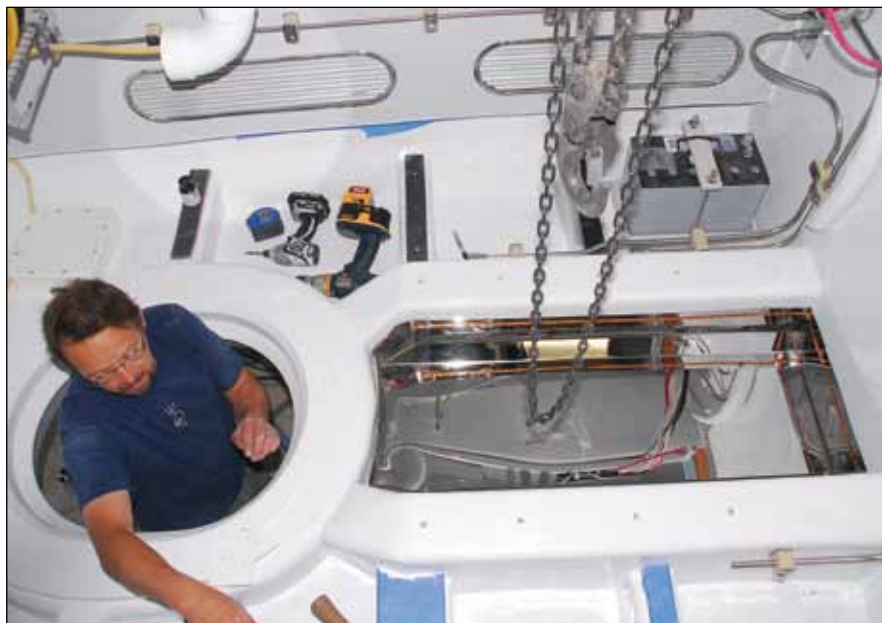
*In the new engine room, the IPS pod-drive engine foundation support and pod unit laminates have been installed and finished. For this project, the fiberglass laminate is wet out in epoxy resin; the engine bed and pod ring structures are foam cored.*

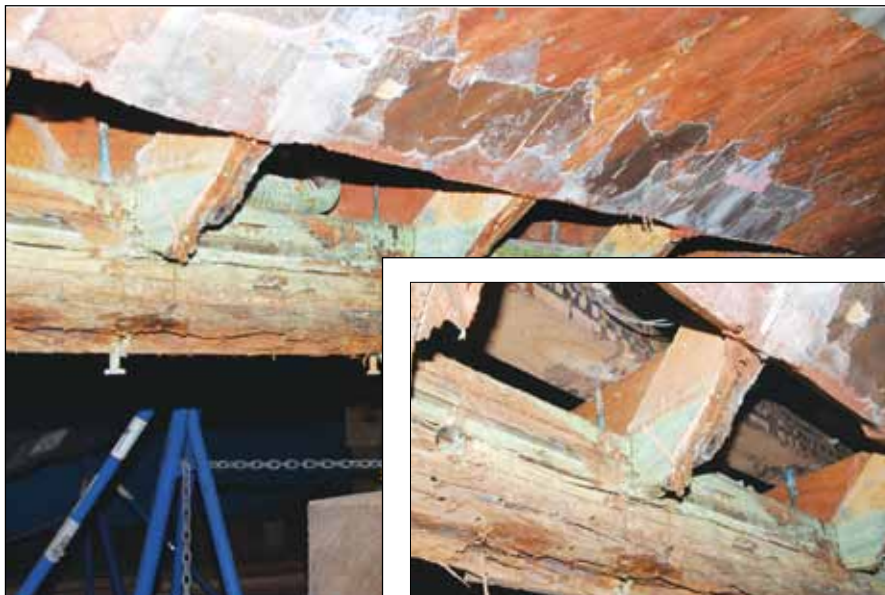
*Cutting back the garboard area forward of the engineroom revealed more deterioration in the frames, floors, and full-length laminated keel and stempiece. That clinched the decision to replace the entire double-diagonal planked bottom forward of the engineroom.*

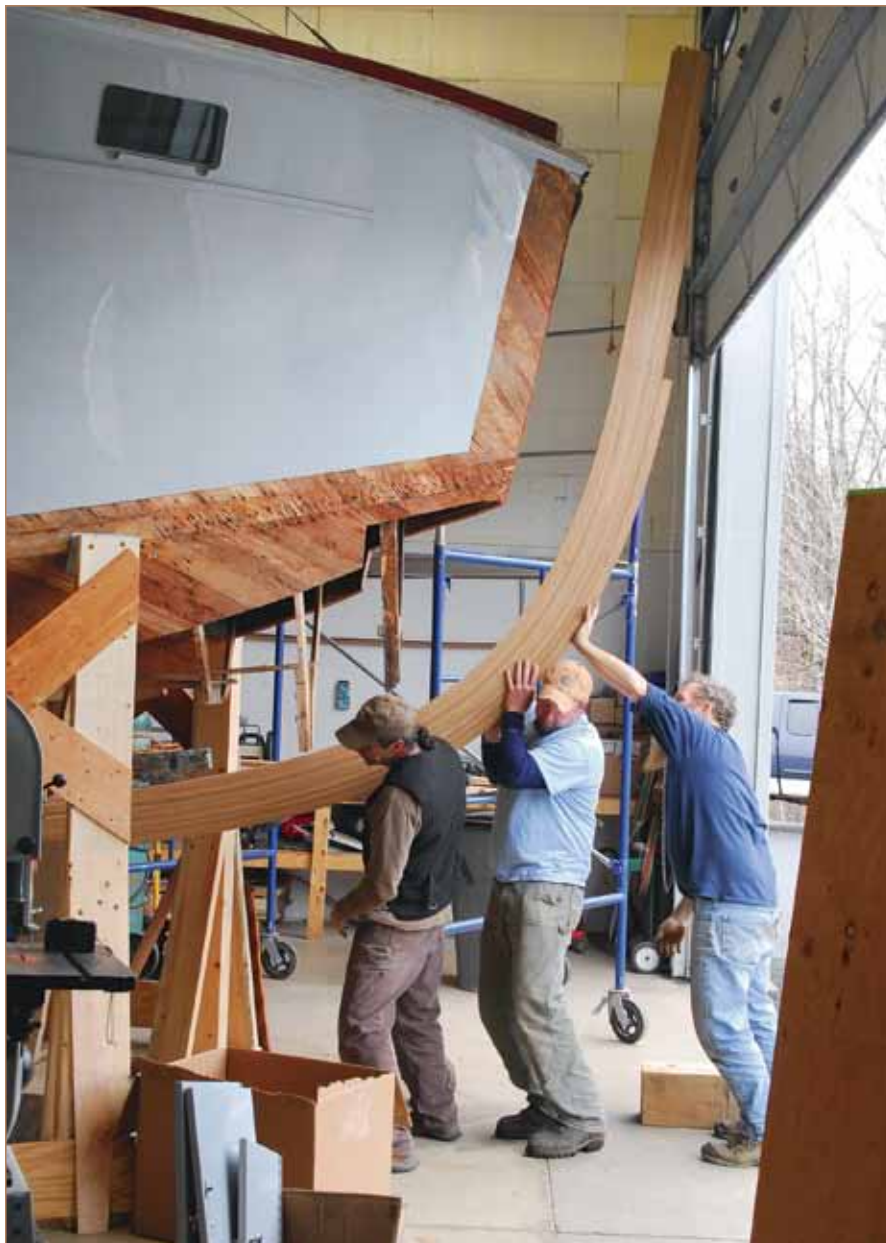
**Top**—The building crew lift the new one-piece laminated stem and keel into place. It fit perfectly the first try. This piece runs from the stem head to the engineroom, where it is scarfed into the new keel section completed in the first phase of the project.

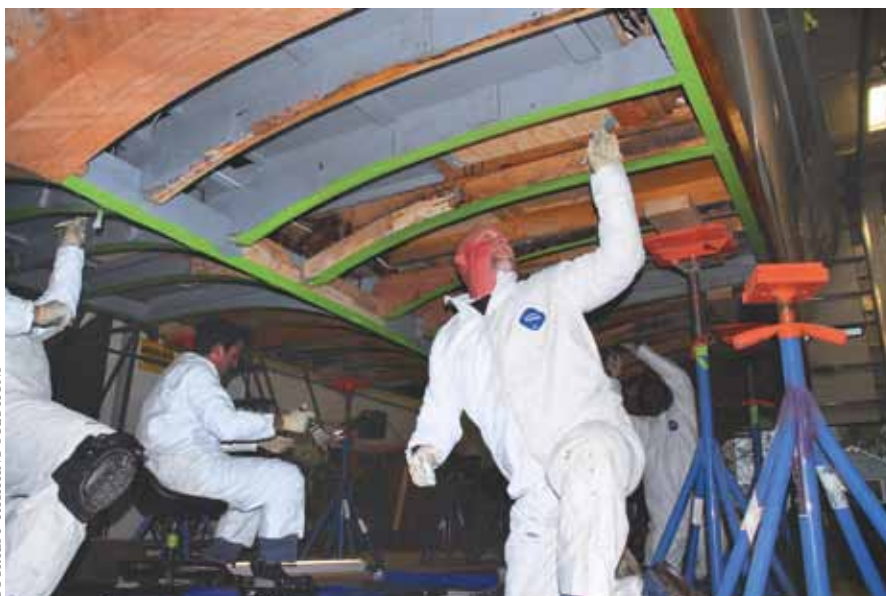
**Top**—Crew dry-fit the first layer of mahogany planking, spiled and cut to width and curvature.

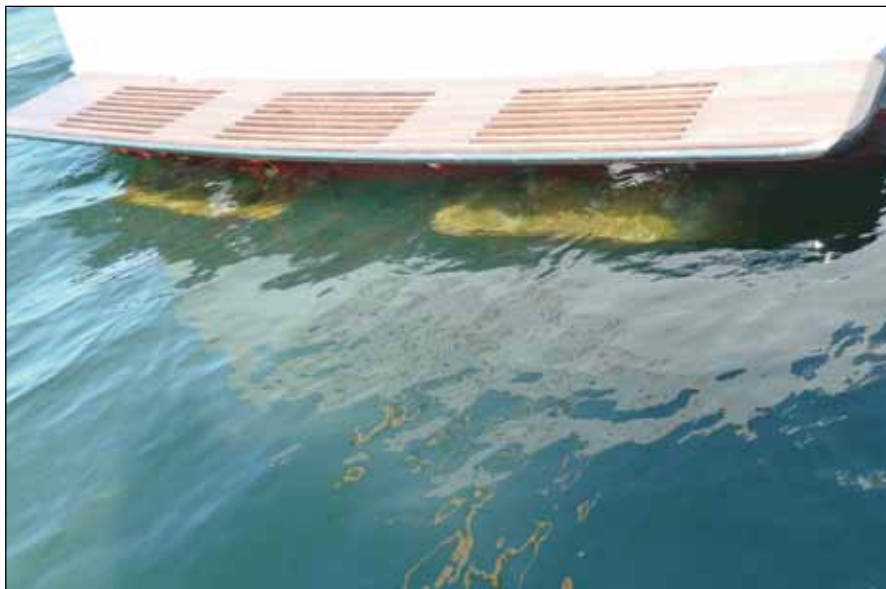
**Top**—Two trim tabs, visible just under the swim platform, and fairing blocks that can't be seen here, were added to adjust the boat's running trim and to bring the bow down. It was one of a few tweaks required after the repower.

forward. So once we found out she ran bow high we added trim tabs faired in with blocks; and these fairing blocks alone, which were proud of the buttocks, were enough to drop the bow 2.5° without even using the tabs. We were also burning up impellers since the exhaust air from the pods was aerating the raw-water intakes, so we had to add snorkels to provide a clean water flow. Volvo provided these as they were already designed for their triple- and quad-engine installations."
