# Pod-Driven Classic

The repower of a wood motoryacht with pod-drive propulsion required rebuilding the entire bottom, but the resulting appearance and performance are exquisite.

by Eric Sorensen

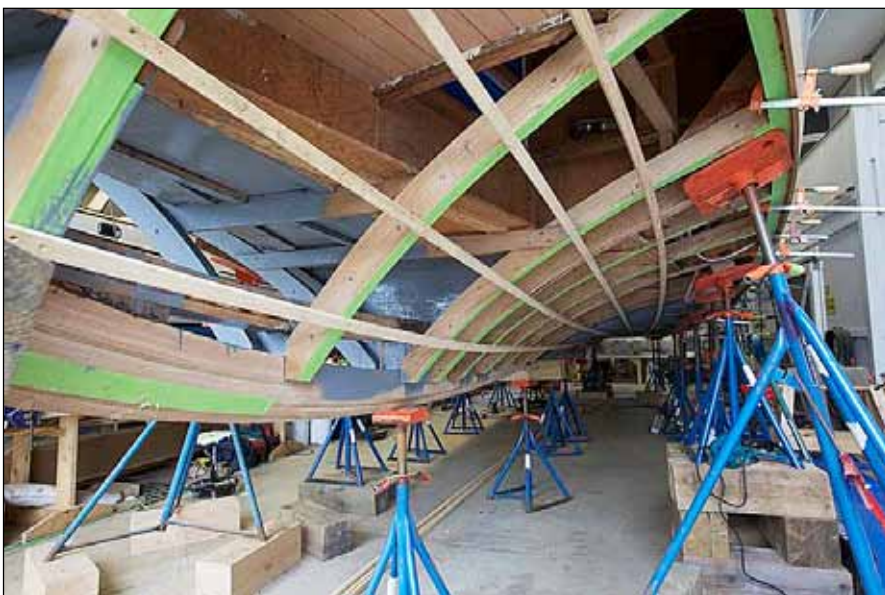
*Cutting back the garboard area forward of the engineroom revealed more deterioration in the frames, floors, and full-length laminated keel and stempiece. That clinched the decision to replace the entire double-diagonal planked bottom forward of the engineroom.*

"We did the top of the keelson first, then the floors and frames afterwards."

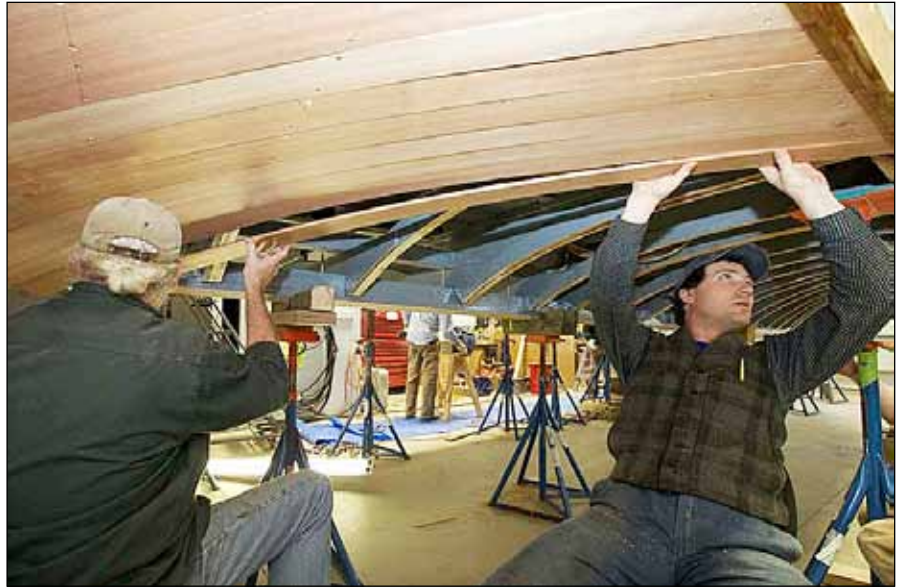
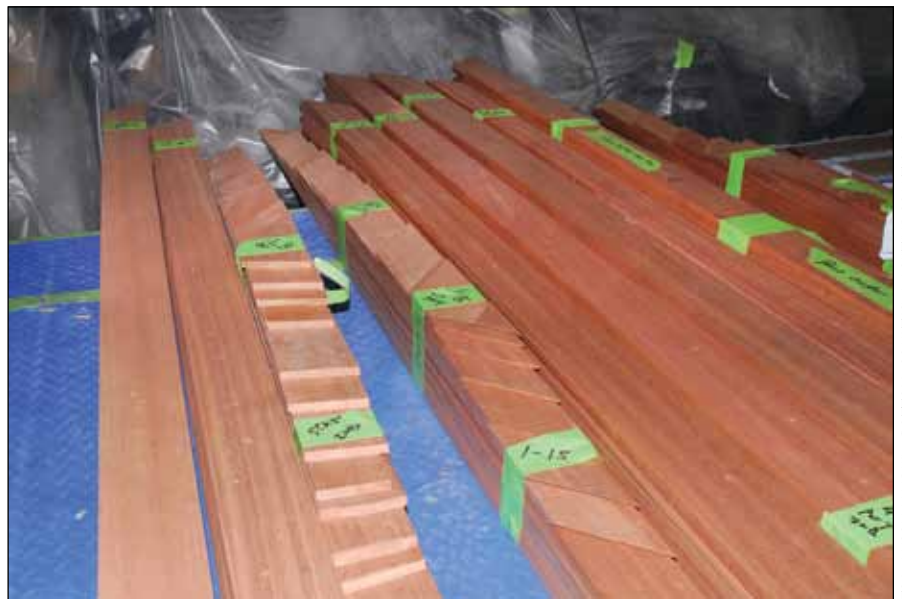
**Top**—The original mahogany double-diagonal planking had been resorcinol-glued and clenched-nailed. When the builders peeled away old fiberglass sheathing, they found deterioration, caused in part by electrolysis. All the planking in the engineroom sections was replaced up to about 1' (305mm) above the waterline.

**Middle**—Although some rot was evident, the initial decision to replace the aft 9' (2.7m) of the bottom was made chiefly because the epoxy fiberglass laminate required by Volvo would not adhere to the oil-soaked planking below the engineroom.

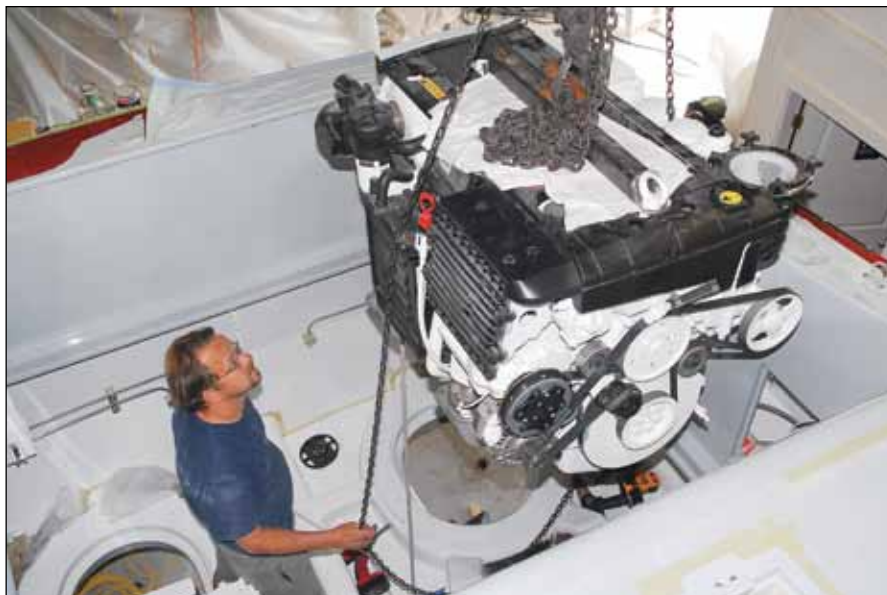
**Top**—With the hull ready for the new engines and drive system, which were the impetus for the entire job, the port Volvo D4 diesel is lowered into place.

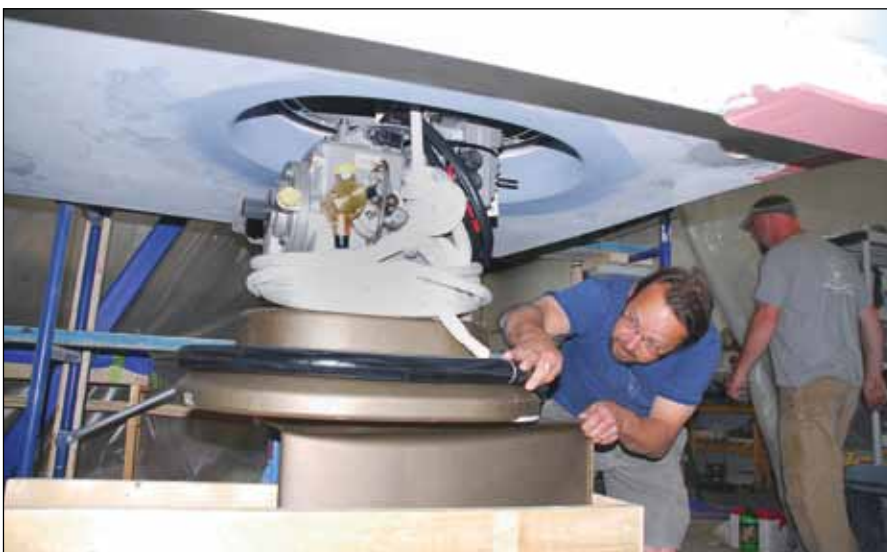
**Middle**—The starboard IPS pod is positioned and ready to be raised into the drive port and attached to the engine above. Note the large black rubber gasket; it's designed to remain in place to keep the hull watertight in the event the lower pod unit shears off in a high-speed grounding.

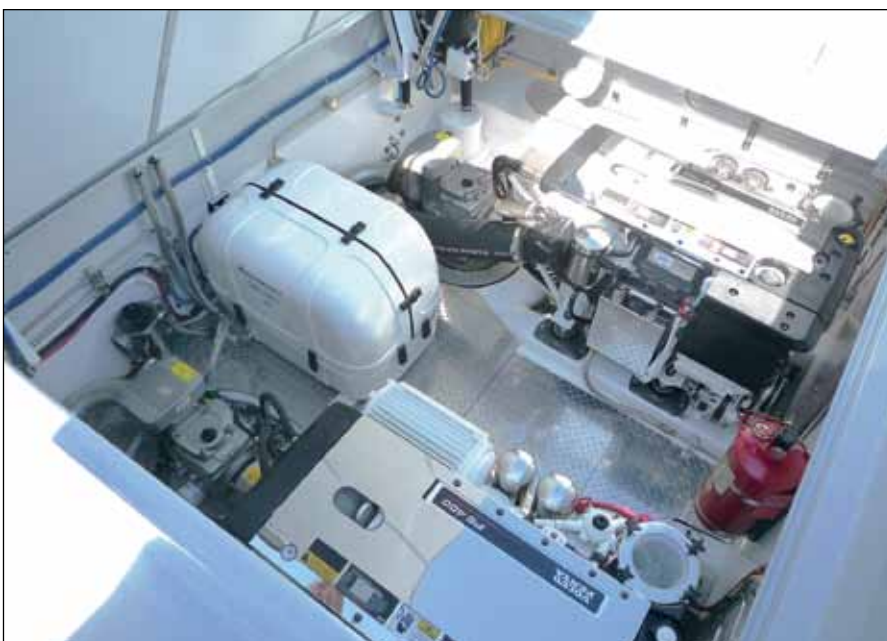
**Bottom**—Besides its impeccable finish and the fit of components, including the generator and sea strainers, the new engineroom is totally accessible—the entire cockpit deck is a hatch opened and closed by hydraulic lift rams.

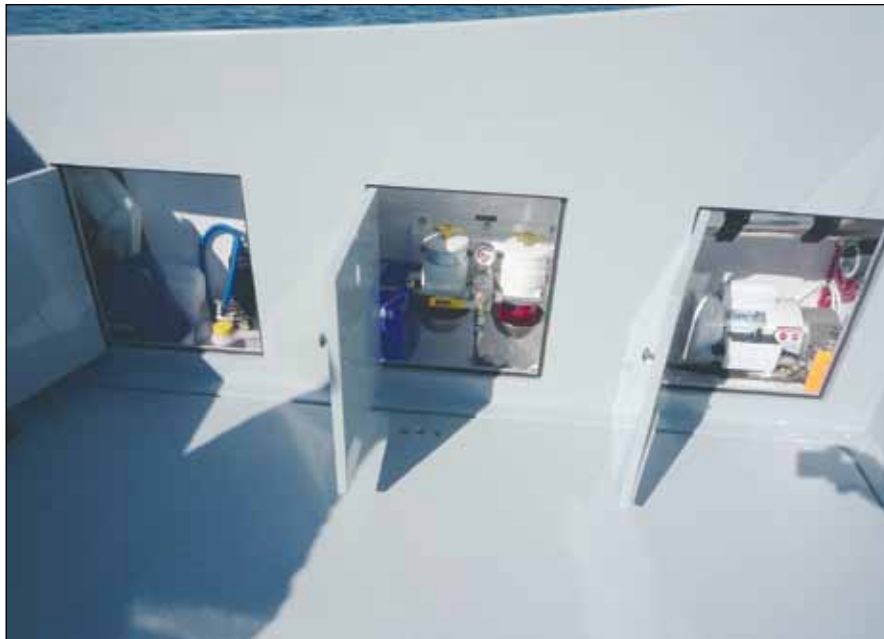
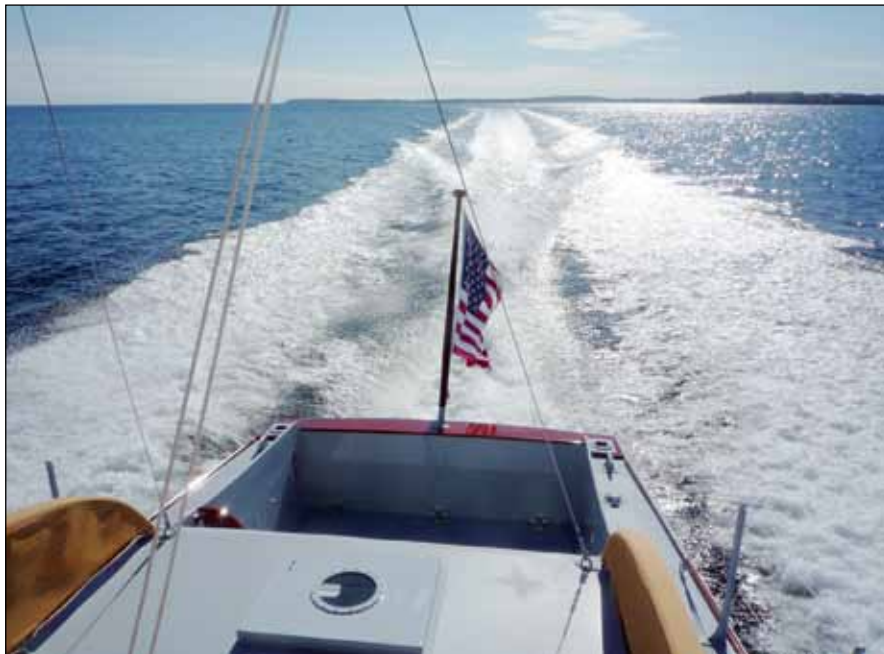
**Top**—Two trim tabs, visible just under the swim platform, and fairing blocks that can't be seen here, were added to adjust the boat's running trim and to bring the bow down. It was one of a few tweaks required after the repower.

forward. So once we found out she ran bow high we added trim tabs faired in with blocks; and these fairing blocks alone, which were proud of the buttocks, were enough to drop the bow 2.5° without even using the tabs. We were also burning up impellers since the exhaust air from the pods was aerating the raw-water intakes, so we had to add snorkels to provide a clean water flow. Volvo provided these as they were already designed for their triple- and quad-engine installations."

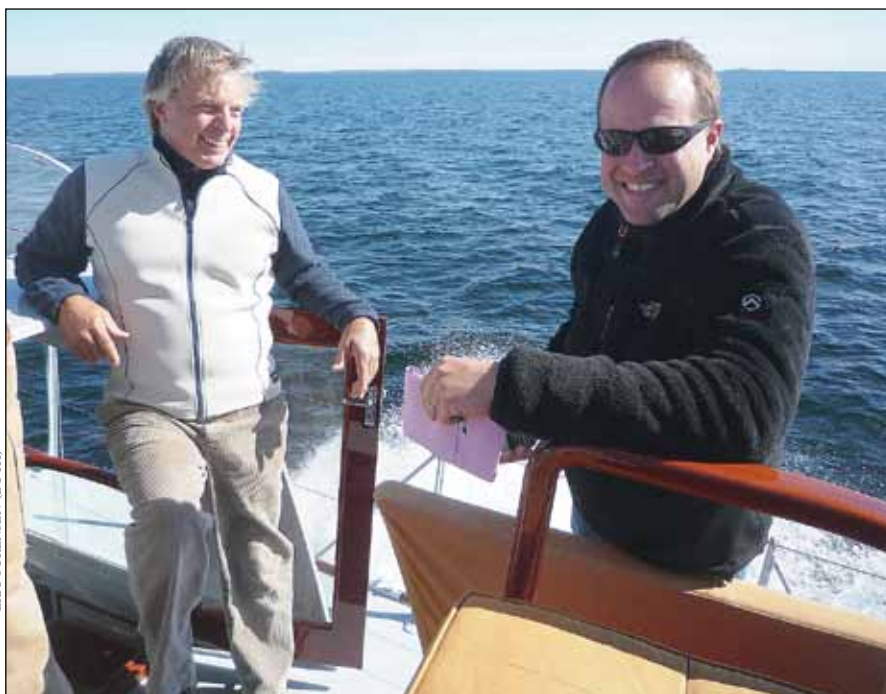
**Bottom**—Northern Spy's owner, Sam Rowse, left, and Bill Morong of Yachting Solutions enjoy late-season sea trials. Although the bugs seem to have been worked out of the new propulsion system, Morong constantly amended the to-do list in his notebook.
